Analysis of timber weathering and wind velocity at Cape Adare, with comments on other historic sites in Antarctica

David L. Harrowfield

ABSTRACT. At Cape Adare, there are three wooden historic huts in varying condition. Two are the first permanent structures erected in Antarctica for human habitation and were occupied in 1899 by the British Antarctic Expedition (1898–1900) led by C.E. Borchgrevink. The third hut was built in 1911 by the northern party of R.F. Scott's British Antarctic Expedition (1910–13) led by V.L.A. Campbell. Previous research has focused on the unusual wind regime at Ridley Beach, Cape Adare, with the use of an environmental wind tunnel to support field observations, and on the sequence of destruction by wind of the 1911 hut. The present paper focuses on the weathering of timber at some historic huts in Antarctica and presents observations and data collected on three visits to Cape Adare spanning 21 years. The results indicate that over 23% of the timber has been eroded from exposed board ends on one corner of Borchgrevink's 'stores hut' and further damage to the huts is being caused by wind blown sand and pebbles which, at two meters above the ground surface

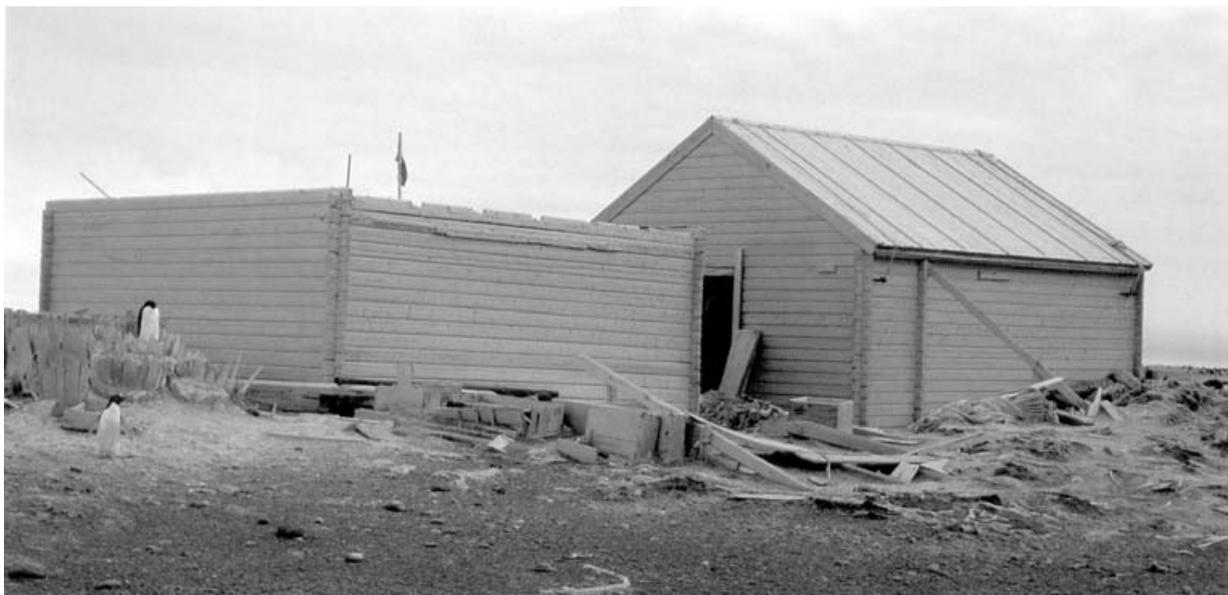
Fig. 3. Borchgrevink's huts, Cape Adare, viewed from the south east. January 1982.

Borchgrevink's equipment included two prefabricated huts of Norwegian design, made by Strømmen Trevarefabrikk near Christiania (Oslo) (Fig. 3). One was for stores and measured 5.2 m² and one was for accommodation and measured 6.4 m². Both were made from clean, mostly knot-free, tongue and grooved boards, 60–70 mm thick and 145 mm high and of 40–70 year Norwegian spruce (*Picea abies*) with a density of 368 kg/m³ for a dried sample from Cape Adare (P. Fuller, personal communication, 2005). According to M. Morrison, conservation architect, the wood used was of 'extremely good quality'.

The two huts were aligned north-south and separated by an alleyway about three meters wide, which at the time of the expedition, was enclosed. On each hut the east-facing roof line was extended to ground level which over the past 106 years, has gradually built up with wind-blown pebbles and guano from nesting penguins. Today Borchgrevink's 'living hut' is in good condition although his 'stores hut', which had the roof removed in 1900, is in only fair condition.

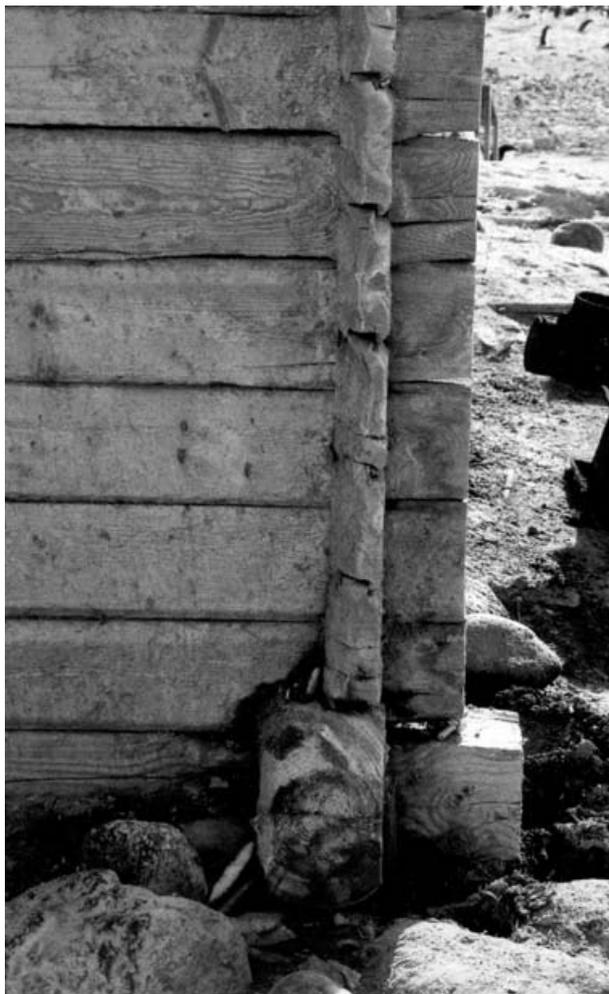
Fig. 4. Weathered northeast corner, Borchgrevink's 'stores hut' with coating of salt and sand particles. January 2003.

Table 1. Measurements for weathering of board ends from the northeast corner of the 'stores hut'. Beginning at lower part of board, readings were taken at 2 cm intervals up the board.

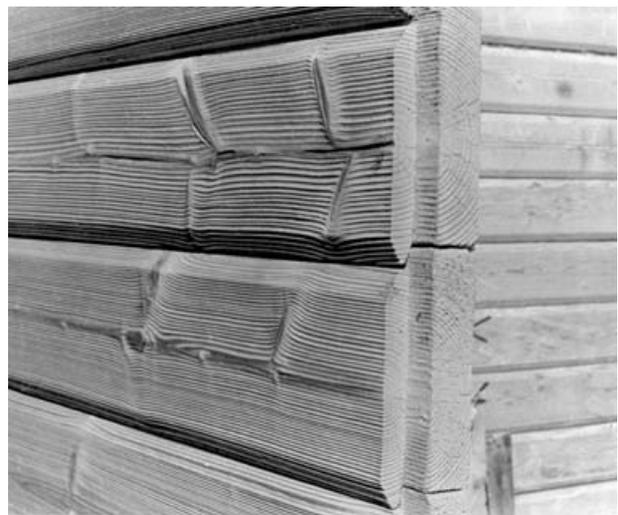
Fig. 5a. Weathered north wall boards, Borchgrevink's 'stores hut'. January 1982.

On the north wall of the stores hut, a vertical profile of weathering was also obtained using sheet dental wax softened in boiling water on a Primus stove and applied with a 'release agent' of plastic film, to prevent the wax adhering to the wood while at the same time retaining the cast and the heights at which the most severe weathering occurred, were similar to the north-east corner (Figs. 5a, 5b).

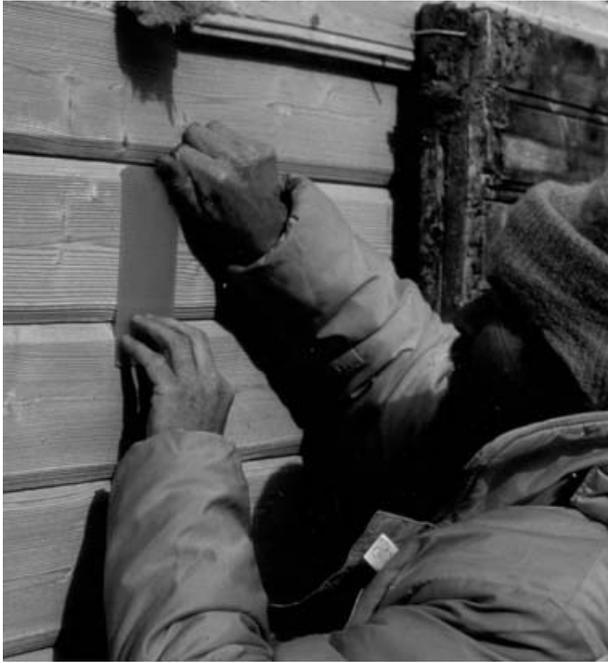
Fig. 5b. Obtaining dental wax cast from north wall boards 'stores hut'. January 1990.

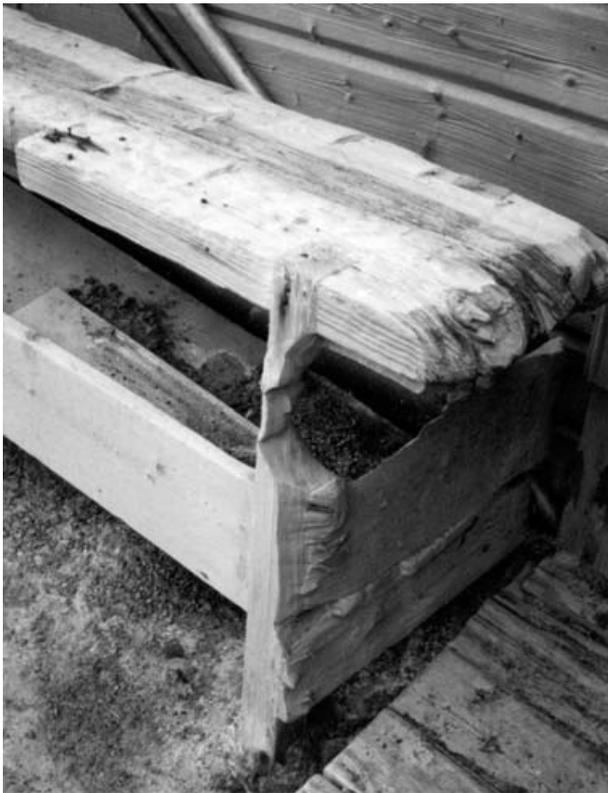
In the alleyway, there is severe weathering to the east end of the 1899 carpenter's work bench positioned against the south wall of the 'living hut'. The maximum weathering of the most exposed bench support originally

Fig. 6. Severely weathered end carpenter's work bench. January 1990.

55 × 67 mm has the 55 mm dimension now reduced at 54 cms above ground level to 19 mm. The bench top 73 cm above ground level is badly abraded at the east end (Fig. 6). This damage is probably associated with

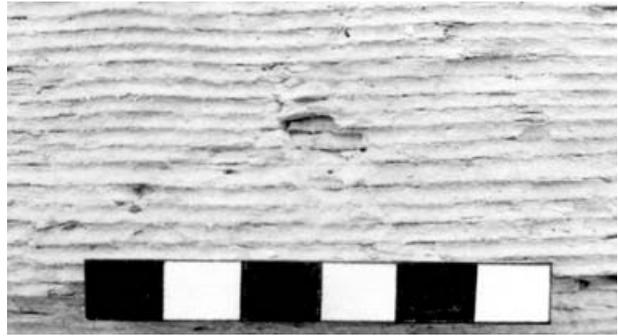
Fig. 7a. Bruising from beach pebble, east wall 'stores hut'. Each scale division 1 cm. January 1982.

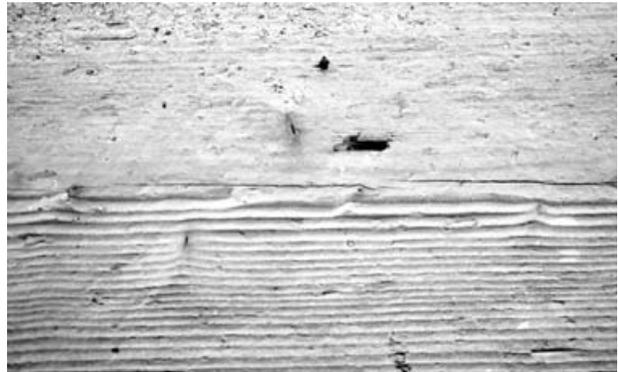
Fig. 7b. Embedded part of basalt pebble, east wall 'stores hut'. January 1982.

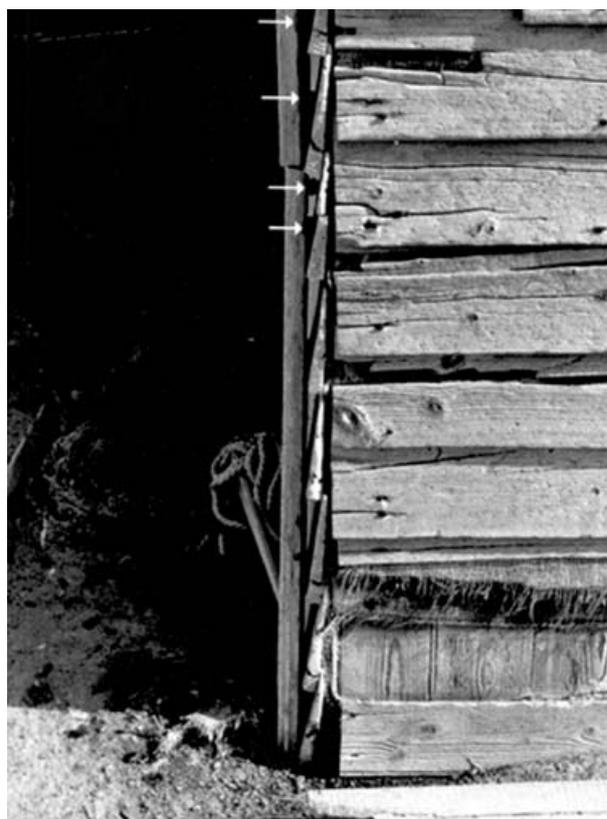
Fig. 8. Pebbles embedded between boards of porch wall 1911 hut. January 1990.

south-east corner of the cold porch and positions were recorded for height above ground level and depth of penetration (Fig. 8). The particles were likely to have originated from the penguin nesting areas east of the hut.

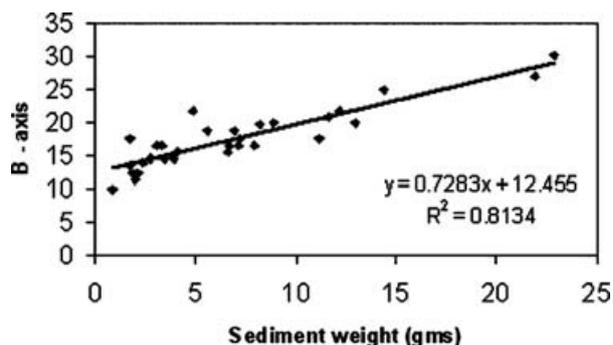
There was a strong correlation, with an 81% level of confidence, in the relationship between particle weight and the B-axis, with a reduction in the B-axis as weight increased (Fig. 9), but only a slight correlation between pebble weight and depth of penetration between the boards with many pebbles within 100 cm of the ground surface. The depth of penetration ranged from 0.5–

Fig. 9. Relationship particle weight to pebble B-axis 1911 hut.

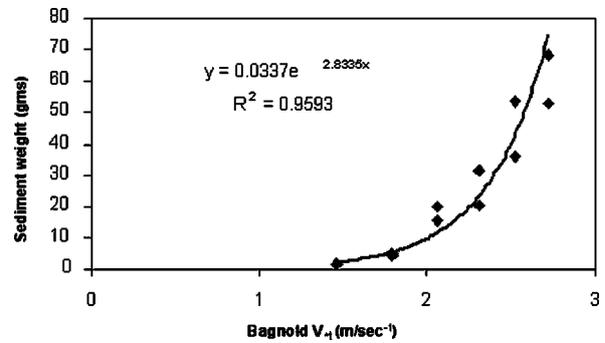
Fig. 10. Predicted velocities for particles at threshold velocity with weight 0–80 gms.

velocity, there is a greater chance for a given particle to be suspended in the airflow (Fig. 10). However, as height above substrate increases, sediment transport is likely to diminish and this is especially so when particle weight increases (Fig. 11).

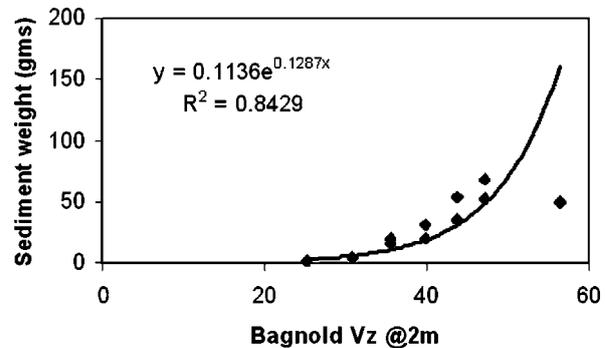
Fig. 11. Predicted velocities for particles above threshold velocity with weight 0–200 gms.

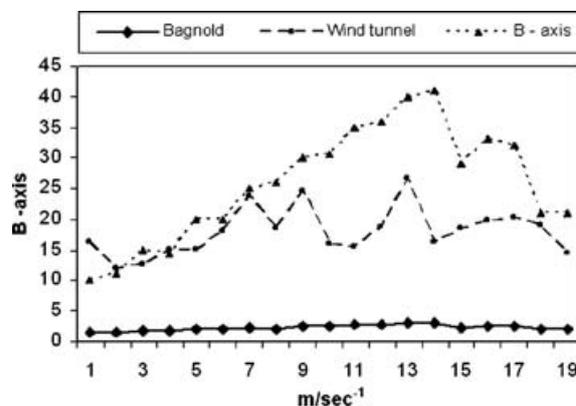
Fig. 12. Comparison of Bagnold predicted velocities with wind tunnel and B-axis of particles tested.

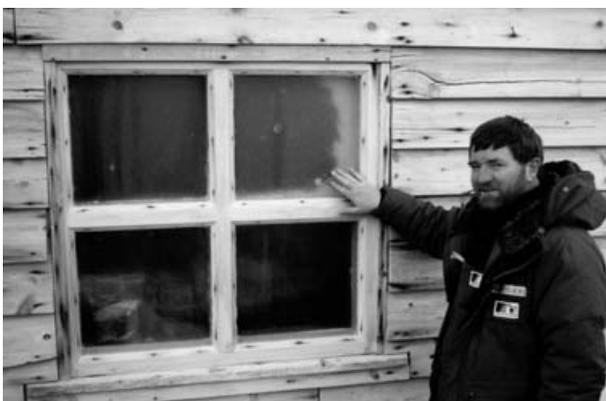
Fig. 13. Abraded glass of window on southeast wall, Scott's hut Cape Evans. January 1998.

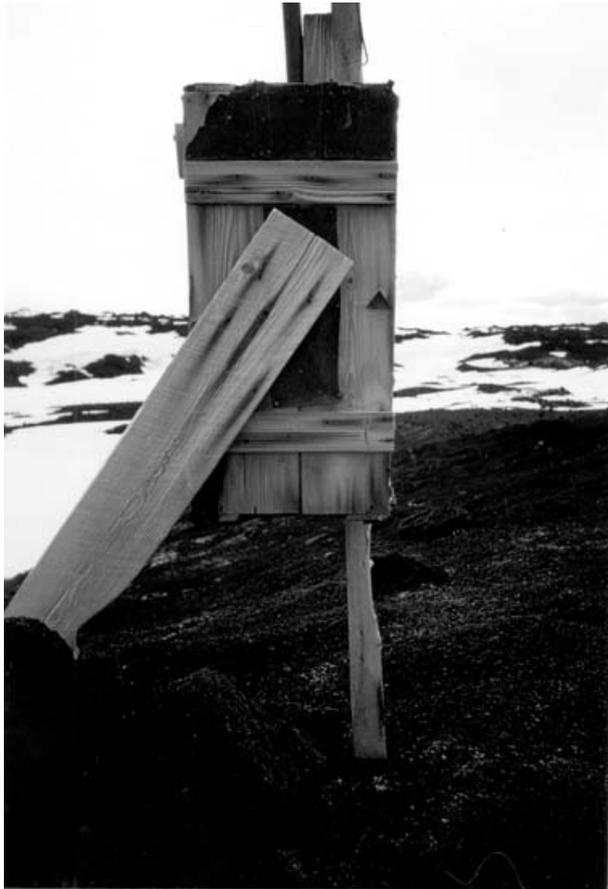
Fig. 14. Weathered instrument housing and support instrument stand, Wind Vane Hill, Cape Evans. January 2004.
