# Environmental pollutants from the Scott and Shackleton expeditions during the 'Heroic Age' of Antarctic exploration

**ABSTRACT.** Early explorers to Antarctica built wooden huts and brought huge quantities of supplies and equipment to support their geographical and scientific studies for several years. When the expeditions ended and relief ships arrived, a rapid exodus frequently allowed only essential items to be taken north. The huts and thousands of items were left behind. Fuel depots with unused containers of petroleum products, asbestos materials, and diverse chemicals were also left at the huts. This investigation found high concentrations of polyaromatic hydrocarbons in soils under and around the historic fuel depots, including anthracene, benzo[b]fluoranthene, benzo[k]fluoranthene, chrysene, fluorene, and pyrene, as well as benzo[a]anthracene, benzo[a]pyrene, and fluoranthene, which are recognized carcinogens. Asbestos materials within the huts have been identified and extensive amounts of fragmented asbestos were found littering the ground around the Cape Evans hut. These materials are continually abraded and fragmented as tourists walk over them and the coarse scoria b

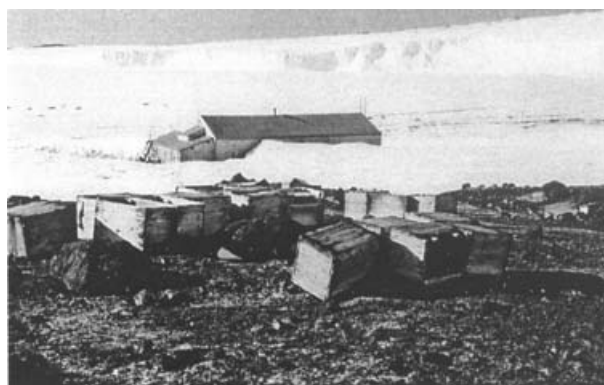
Soil samples taken adjacent to historic petroleum containers and at 1- and 2-m intervals in two fuel depots located at Cape Evans hut (Figs 1 and 2) show that petroleum products have spilled or leaked from containers and have contaminated the area. At the lower fuel depot, high levels of total petroleum hydrocarbons were present adjacent to the containers from the soil surface to a depth of 15 cm, where the ice-cemented zone was located (Table 1). The contamination was also found at the soil surface and at a 5-cm depth located 1 m from the containers. A similar set of samples taken from the upper fuel depot immediately adjacent to the fuel boxes and at 1- and 2-m intervals showed that total petroleum hydrocarbons for C<sub>7</sub>–C<sub>9</sub>, and C<sub>10</sub>–C<sub>14</sub> were below the detectable limit. However, at the 5–10 cm depth soil sample, taken adjacent to the fuel container and just above the ice-cemented layer, 600 mg kg<sup>-1</sup> of C<sub>15</sub>–C<sub>36</sub> compounds were present. All other soil samples taken away from the fuel containers at this depot had levels of hydrocarbons below the detectable limit. For both fuel depot sites, no attempt was made during this sampling to dig below the ice-cemented layer nor to move any of the containers since this would have resulted in excessive disturbance of the site. There appear to be few low molecular weight hydrocarbons present in these samples from the various locations tested (Table 1). The residual total petroleum hydrocarbons present at the site were unresolved complex material. Over the past decades these low molecular weight compounds may have been evaporated, leached, or transported out of the area. Since this is one of the oldest petroleum spills in Antarctica and the compounds have been in the soil for more than nine decades, some degradation by soil microbes could also have taken place. The high molecular weight compounds present in

Fig. 1. Fuel depot at Cape Evans near the historic hut. High concentrations of polyaromatic hydrocarbons are in soils below and around the fuel containers.

the contaminated soils at the lower fuel depot include high concentrations of phenanthrene, pyrene, chrysene, benzo[b]fluoranthene and benzo[a]pyrene (Table 2). Concentrations at this site are exceedingly high as compared to other petroleum spills in soils from around Scott Base, McMurdo Station, and the former Vanda Station (Aislabie and others 1999; Mazzera and others 1999). While naphthalene and or methylnaphthalenes predominated in samples from Scott Base and McMurdo Station in these previous investigations, they are absent

1. Petroleum spills. Large concentrations of polyaromatic compounds, many of which are known carcinogens, have spilled into the soils at the historic fuel depot areas. At the lower depot, the contaminants are present immediately below and around the containers and the contamination extends up to 1 m away. In the upper fuel depot, the contaminants appear restricted to the area immediately under and adjacent to the containers. The Protocol for Environmental Protection to the Antarctic Treaty (1991), in Annex III, Article 1, indicates that past and present waste-disposal sites on land and abandoned work sites of Antarctic activities shall be cleaned up by the generator of such wastes and the user of such sites. However, this does not include removal of any structure designated as a historic site or monument or the removal of any waste material in circumstances where the removal would result in greater adverse environmental impact than leaving waste material in its existing location. It appears appropriate that all containers should be emptied of their petroleum materials so that continued release of polyaromatic compounds into the environment does not occur. Since the levels of contamination in the soil exceeds current standards used to determine if clean-up is required at sites where petroleum spills have taken place, one method of control would be to remove the contaminated soil under and around the fuel boxes and transport it out of Antarctica for remedial treatment. The historic site, however, contains numerous artifacts on the ground and in the top layers of the gravel, and excavation and removal of the contaminated soil would need to be done under the supervision and guidance of an archaeologist. Disturbance of the historic site with its rich cultural heritage is of great concern, and drastic measures, such as the removal of large quantities of soil, need careful consideration. Additional studies are needed to determine if the level of contamination within the historic boundaries is confined to the site and if it poses a threat to the surrounding Antarctic environment. Since this is the oldest known petroleum spill in Antarctica, the site also has potential scientific value to serve as an experimental area for studying and isolating native micro-organisms that grow in the contaminated soils and may be able to degrade

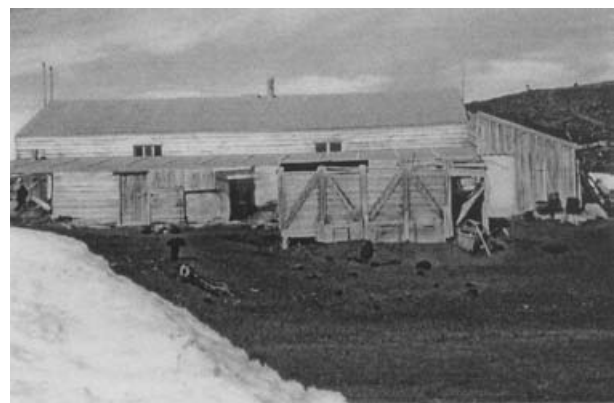
Fig. 5. Snow-free area round Cape Evans hut that contains several hundred pieces of asbestos on the surface of the ground.

2. Materials containing asbestos that litter the area around Cape Evans should be removed. Several hundred pieces larger than 1 cm<sup>2</sup> are on the surface of the ground in the snow-free areas around the hut. These materials continue to be fragmented and abraded as visitors to the site walk around the hut. It is not known how much additional asbestos exists under snow and ice, but as it melts the exposed asbestos should be removed. The larger pieces of asbestos can be easily collected, properly contained, and shipped out of the Antarctic for disposal. The smaller sized materials (less than 1 cm<sup>2</sup>) and materials below ground, however, will require significant effort to collect. The structure that contains the hut used for magnetic observations appears to be functioning. This structure has significant historic value and should remain at the site. Although the current wooden structure covering the hut functions very well to contain the asbestos-lined hut, Antarctica's severe weather is taking its toll on the wood (Blanchette and others 2002). Wind and salt will continually erode the plywood used in the building causing it to delaminate and deteriorate. This structure must be maintained and upgraded in the near future. A more stable and permanent containment building will be needed to insure that the large amount of asbestos in this historic hut remains confined to the building. A structure that can withstand severe storms (and possibly allow visitors to view the magnetic hut through Plexiglass or other similar material) is needed to prevent the possibility of an extremely large amount of asbestos material being broadcast into the environment should the containment structure be destroyed by katabatic winds or other extreme weather conditions.

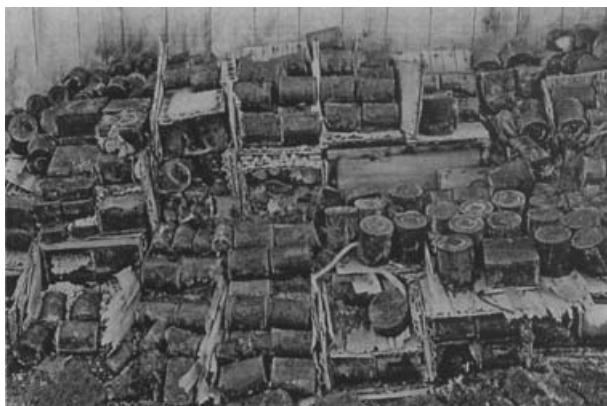
Fig. 6. Deteriorating cans and wooden crates of food stores left at the Cape Royds hut.

outside of the hut, and around the Cape Evans hut (Fig. 6). Many of the soils near these materials had concentrations of up to 1620 ppm lead (Table 4). In samples taken from soils without storage crates or deteriorated canned goods nearby (Table 4: sample taken from the north corner of Cape Evans hut), concentrations were only 7 ppm.

3. The presence of heavy metals around the hut from lead-deteriorated paint is localized to a few areas immediately adjacent to the *Discovery* hut. A greater concern is the heavy metals that appear associated with the deteriorated canned goods around the Cape Royds and Cape Evans huts. As more of the canned goods stored at the huts continue to deteriorate, additional metal ions will be released into the soil. The movement and distribution of these heavy metals into the Antarctic environment should be studied to determine if any potential hazards could develop. The lead/zinc flashing materials that are at the site should be removed to avoid future weathering and release of additional metal ions into the soil. The historic woods that currently have increased levels of lead pose no problems, but locations should be noted when future restoration work is done. High concentrations of chromium and lead exist in woods affected by the chemical spill inside the Cape Evans hut. Access to this area should also be restricted to avoid the fragile defibrated wood being disturbed and possibly dispersed within the hut. Since the caustic substance is still in the wood and deterioration is likely to be continuing, these areas need special conservation efforts to remove the toxic substances from the wood and consolidate the affected woods.

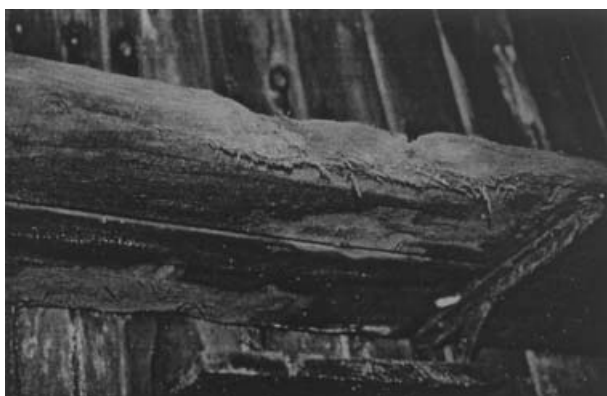
Fig. 7. Chemical spill inside the Cape Evans hut causing a deterioration of the wood. High concentrations of chromium and lead are associated with this caustic chemical spill.

A very unusual type of wood deterioration was found within the Cape Evans hut affecting the shelves, wall, and table at the east end of the hut used by the expedition crew as a science laboratory (Fig. 7). Affected wood has been extensively defibrated, changing the normal structure of the wood to masses of brown fibrous material. Elemental analyses of this deteriorated wood showed high levels of copper, chromium, iron, and lead, suggesting that a caustic chemical spill had occurred. The chemicals were absorbed into the wood and have caused a destructive dissolution of the wood cell structure. This type of deterioration appears similar to advanced stages of attack observed by salts and other chemicals to wood (Blanchette and others 1991, 2002) where the lignified intercellular regions of the woody cell walls have been degraded. The deteriorated wood is also similar to degraded wood found in the historic

laboratory of Thomas Edison, which apparently was affected by a similar type of chemical spill (Blanchette and others 1991). The chemicals caused a slow degradation of wood, and the process was allowed to continue unchecked because the laboratory is a protected historic building. In the Antarctic, the chemicals absorbed by the wood have had many decades to corrode and alter the cellular structure resulting in the current condition of the wood.

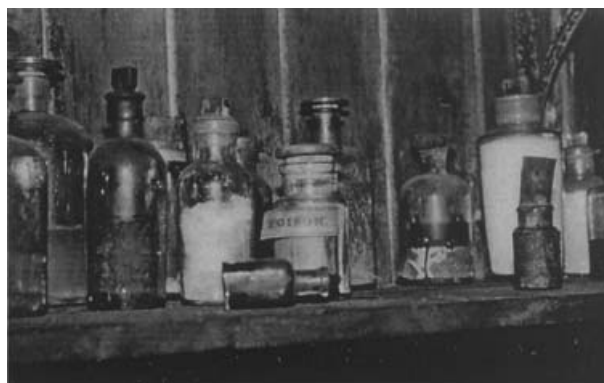
Fig. 8. Bottles of chemicals on shelf in the Cape Evans hut. Most labels that identify the chemicals have deteriorated and cannot be read, but one labelled 'poison' remains.

There are many chemicals in various unlabelled bottles, containers, and glass tubes or other scientific apparatus left within Cape Evans hut that should be evaluated to ascertain their identity (Figs 8 and 9). The high relative humidity found within the huts (authors, unpublished data) has promoted mold growth on paper, textiles, and even wood. These organisms have contributed to the poor condition of many of the labels on the chemical bottles and containers, and most have deteriorated. In the past, conservators from the Antarctic Heritage Trust have catalogued labelled chemical bottles in the historic huts, but many unknown substances remain. Chemical spills may occur by freeze-thawing of liquids and subsequent glass breakage, by inadvertent accidents

4. A review of all scientific apparatus and chemicals in the hut should be completed and toxic or hazardous materials identified. In the event of a future accidental chemical spill, materials to contain and clean up the chemicals are needed within the huts. Test tubes, flasks, and other scientific apparatus containing battery acids, caustic alkaline materials, or any hazardous material should be removed or secured to avoid any possibility of spillage and damage to the historic hut and artifacts.

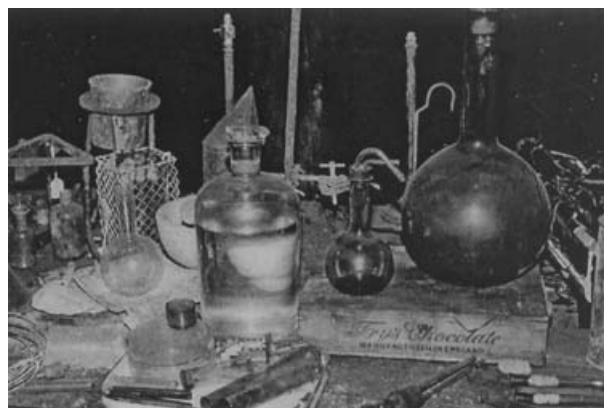
Fig. 9. Many chemicals are still present in the Cape Evans hut, associated with the scientific apparatus left behind by the early explorers.
